**N° CEMIC/ PNR/26-3097/18.03.2026/FT**

**SURVEY REPORT**

**DAMAGE TO THE 20' DRY CONTAINERS No MSDU 116870-3 & SEGU 279332-4 AND POTENTIALLY CARGO INSIDE FOLLOWING AN INCIDENT AT THE CONTAINERS TERMINAL OF THE PORT OF POINTE NOIRE DURING THE TRANSSHIPMENT PERIOD**

**Survey, in 2026, on March 23<sup>rd</sup>**

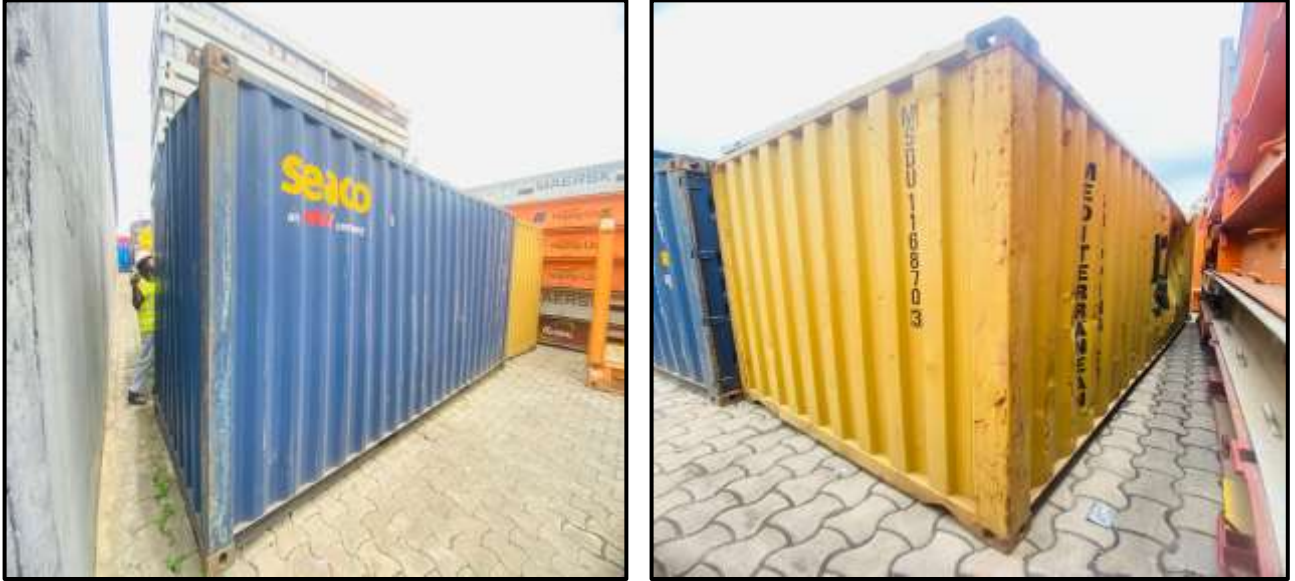
Containers No MSDU 116870-3 & SEGU 279332-4 at OOG area or MINOCO edge area of CONGO TERMINAL

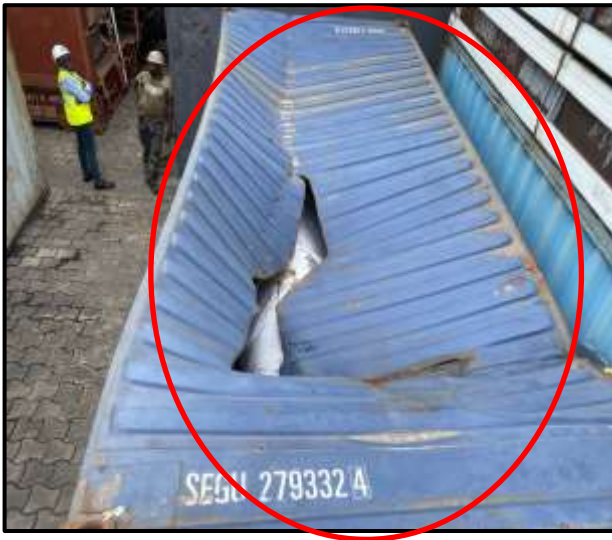
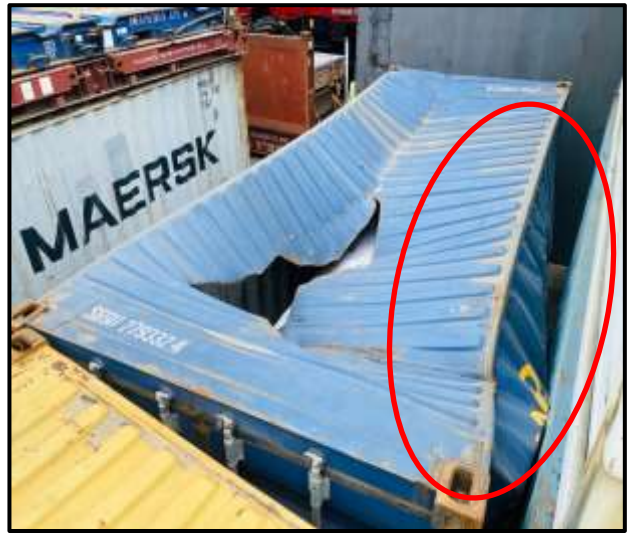
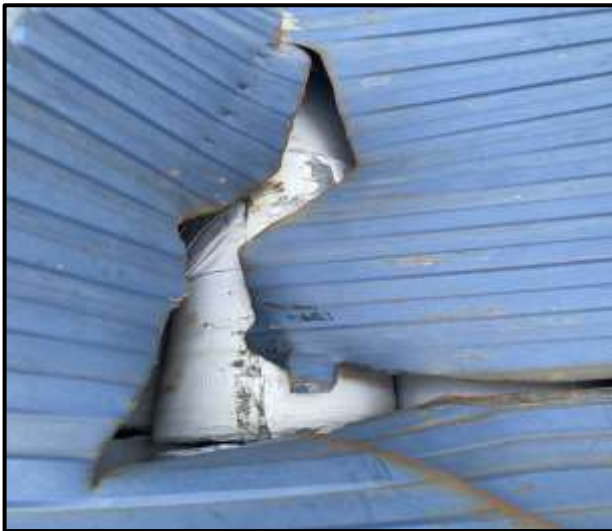
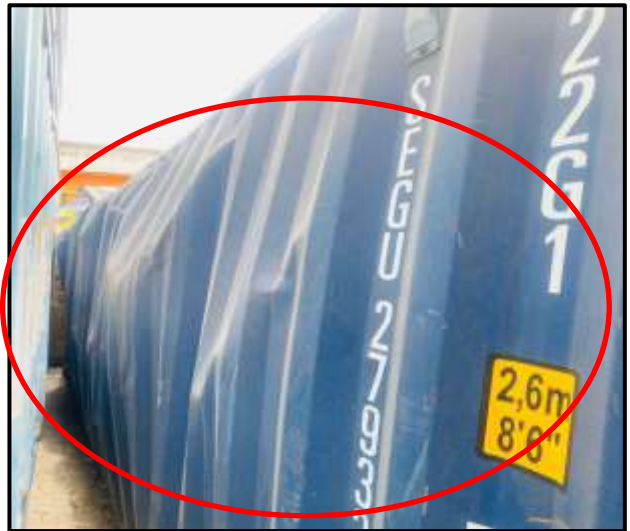
### a) Joint survey on the first container SEGU 279332-4:

- ✓ Presence of a concave-shaped deformation of the left side wall extending from the 2<sup>nd</sup> to the 19<sup>th</sup> undulation starting from the front of the doors;

- ✓ Presence of an oval-shaped deformation of the right-side wall extending from the 1<sup>st</sup> to the 19<sup>th</sup> undulation starting from the front of the doors;

- ✓ Presence of an oval-shaped deformation along of the roof panel;
- ✓ Presence of a perforation of the roof from the 2<sup>nd</sup> to the 13<sup>th</sup> wave starting from the front of the container doors;
- ✓ Left and right top side rail completely deformed.

- ✓ Concave-shaped deformation of the front wall panel of the container from the 1<sup>st</sup> to the 8<sup>th</sup> corrugation

- ♣ **Structural damage to the two dry shipping containers N° MSDU 116870-3 & SEGU 279332-4:** The damage resulted from hazardous or improper handling by the operator Congo Terminal at the port of Pointe-Noire during a lifting operation in the container terminal. This handling caused damage (holes, dents/out of shape, dings and scratches) to the metal structure, corners and roof panels, front panels and the left and right-side walls of the containers.
- ♣ Consequently, the 70 packages of galvanized wire contained in the said dry containers of the unit were not inspected during our pre-inspection at the Congo Terminal and will be subject to a joint cargo inspection after obtaining Customs approval and opening the doors of the containers.

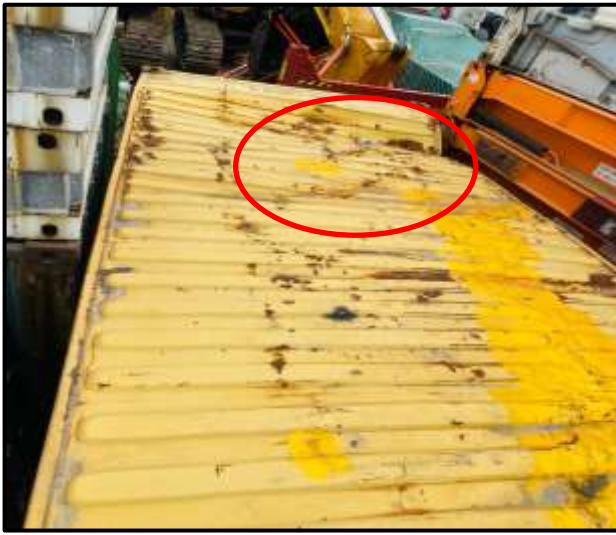
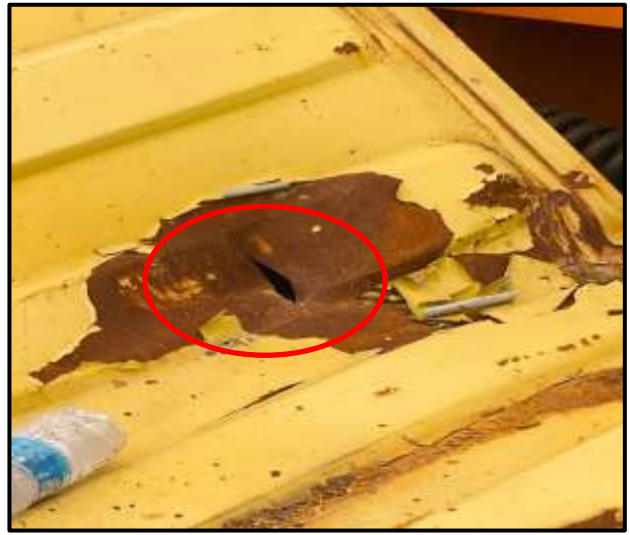
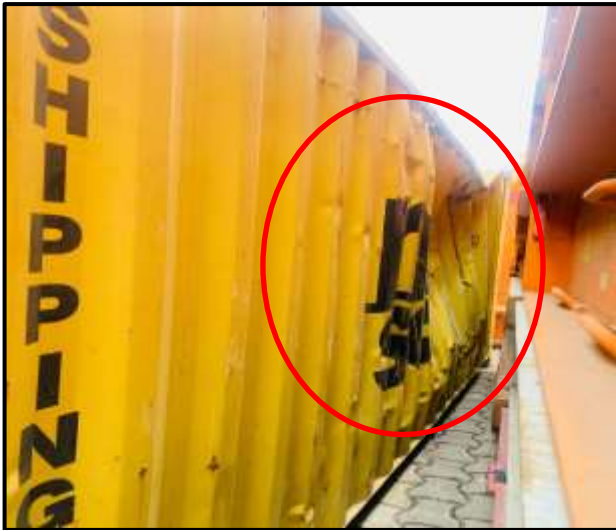
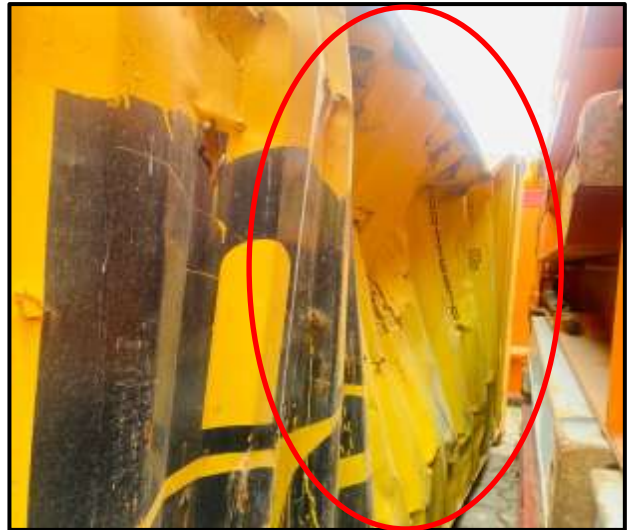
**b) Joint survey on the second container MSDU 116870-3:**

- ✓ Presence of an oval-shaped deformation of the left side wall extending from the 2<sup>nd</sup> to the 10<sup>th</sup> undulation starting from the front of the doors;
- ✓ Presence of a concave-shaped deformation of the left side wall extending from the 10<sup>th</sup> to the 13<sup>th</sup> undulation starting from the front of the doors;

- ✓ Presence of a concave-shaped deformation of the right side wall starting from the front of the doors;

- ✓ Presence of a concave-shaped deformation of the roof panel from the 1<sup>st</sup> to the 12<sup>th</sup> wave starting from the front of the container doors;
- ✓ Presence of a perforation of the roof panel from the 2<sup>nd</sup> to the 3<sup>rd</sup> wave starting from the front of the container doors;
- ✓ Right top side rail completely deformed.

- ✓ Concave-shaped deformation of the front wall panel of the container from the 1<sup>st</sup> to the 8<sup>th</sup> corrugation.

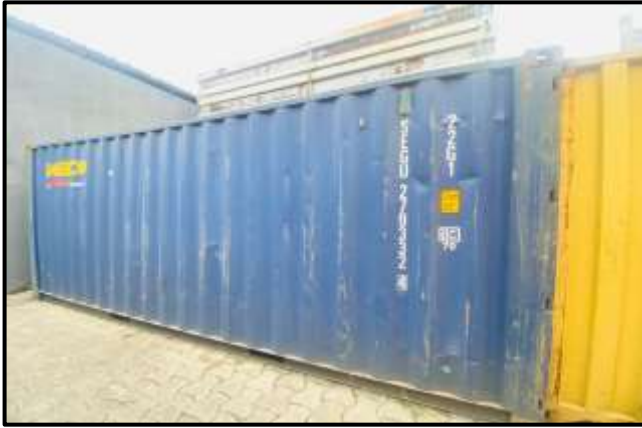
View of the 01 x 20 Dry Container No. SEGU 279332-4 at OOG area or MINOCO edge area of CONGO TERMINAL

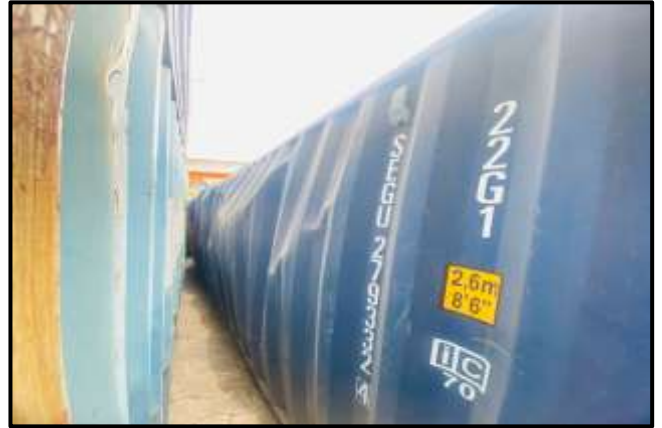
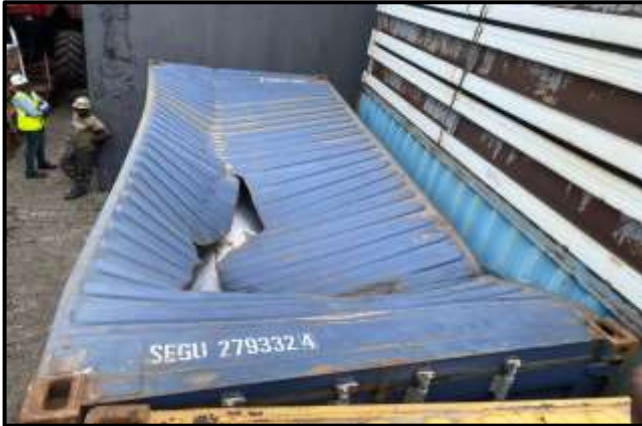
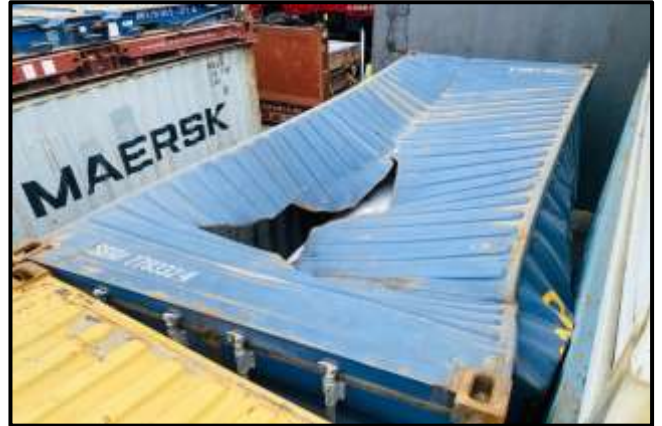
View of the roof panel of container

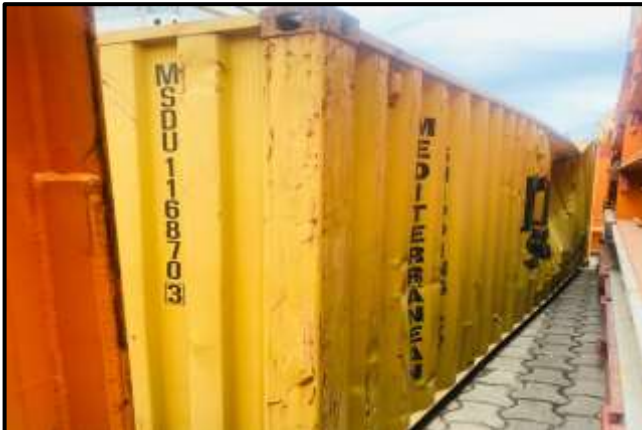
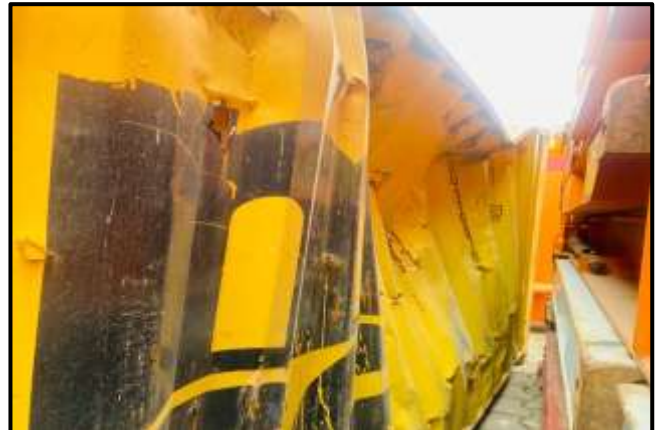
View of the container No. MSDU 116870-3 found damaged during our joint inspection

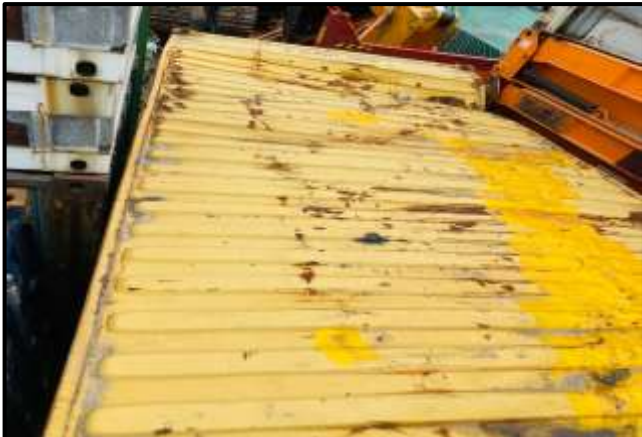
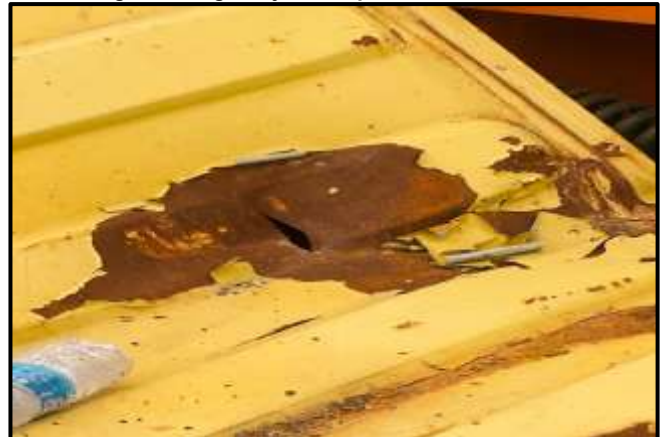
View of the roof panel of container found perforated
